ICC Decoder Module *Troubleshooting Guide*

This troubleshooting guide represents common field conditions and questions related to the ICC Decoder Module. Review the list of “Observed Field Conditions” in the table of contents below and then scroll to the corresponding page.

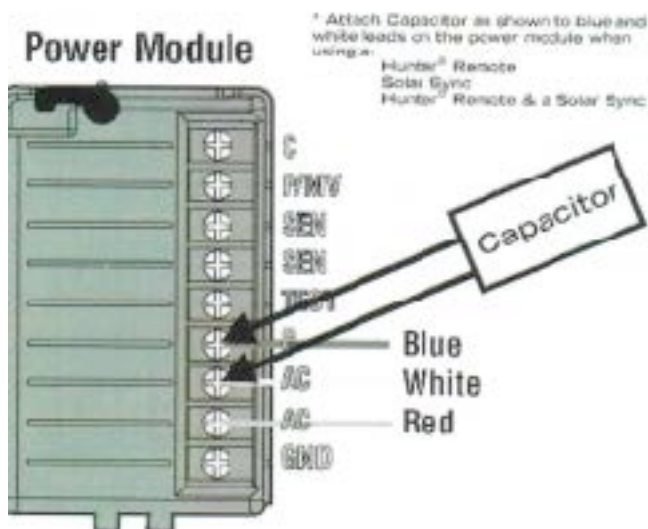
Verify if a blue-colored capacitor has been installed on the Hunter ICC's power module. Generally if this capacitor is missing, the "ERR" message will appear. Call Underhill International and request the quantity of capacitors needed. There is a no-cost fee for these that come complete with installation instructions.

If a capacitor exists and the "ERR" message is still observed, verify the capacitor is making contact with the terminal blocks and/or is installed properly. See diagram below:

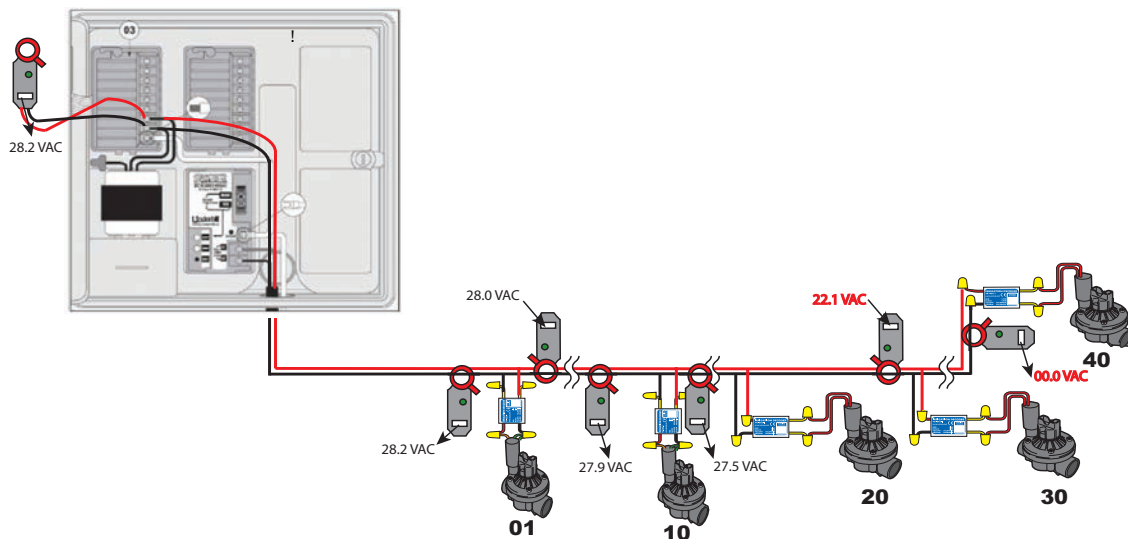
The diagram below shows how a digital clamp meter can be used to take measurements along the 2Wire path as it enters and exists a valve box. Note that only one of the wires is clamped inside of the digital clamp meter. In this example, the 2Wire path is temporarily disconnected from the L1/L2 terminals and connected directly to the 24-volt terminal block of the Hunter ICC power module. **This is done with the 120-volt power to the ICC controller "Off"**. Stations will not operate because they are not receiving a "decoded" message specific to a station number. Using the "halving method" take measurements along the 2Wire path at regular intervals.

Note the two measurements in "red" text showing a drop in AC voltage or none at all. The drop in voltage indicates a nick or path to ground. Check field wire connections to isolate the problem. The 0 volts AC, indicates a break in the 2Wire path. Locate and repair the break as needed.
