T-400

Portable Irrigation Machine Maintenance & Repair Manual

Revised March 1, 2009

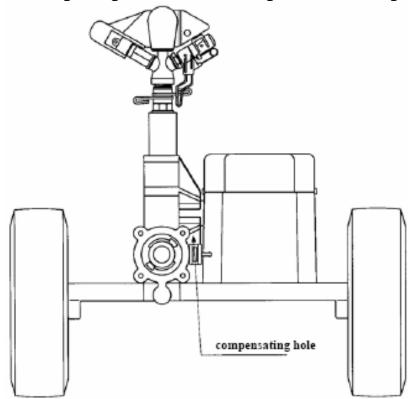
In case of leakage on the compensating hole or in the Tracker[™] housing, check the rotary shaft lip seal. In most cases of this form of leakage, the deep-groove ball bearing in the Tracker[™] housing and the partial deep-groove ball bearing in the gear wheel could be damaged. Check for leakage monthly.

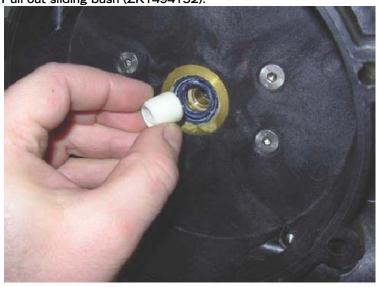
Pull out Tracker™ wheel (BTV784312) with shaft (BTC484330). Pull out sliding bush (ZK1494152).

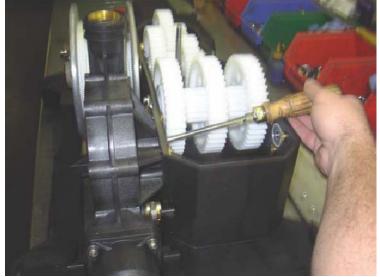
Remove gear and spacer ring from gear case. Tap out shaft seal packing (ZK0994377) with guide bush for shaft (BTC584388).

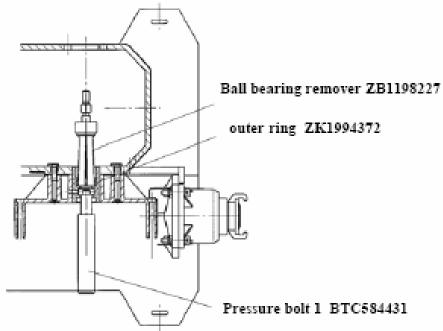
If deep-groove ball bearing (ZK1994372) is defective (individual parts):

Apply internal extractor \emptyset 19-24 and tap through with pressure bolt No.1 (BTC584431) towards gear case.

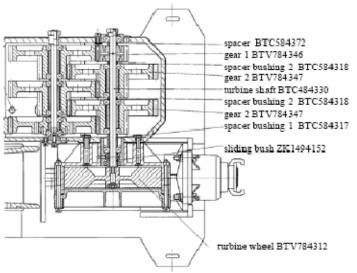
Spacer bushing 1 (BTC584317)
Gear 2 (BTV784347)
Spacer bushing 2 (BTC584318)
Gear 2 (BTV784347)
Spacer bushing 2 (BTC584318)
Gear 1 (BTV784346)
Spacer (BTC584372)

Tightly screw on cover for Tracker[™] shaft (BTC684371) with deep-groove ball bearing (ZK1994372) (3x ZD0293188)
