Golf Course Management Magazine  
[www.gcsaa.org](http://www.gcsaa.org) • June 2014

# Weathering long-term drought with improved irrigation

Converting to solid metal nozzles improves distribution uniformity and reduces costs at a top Texas course.

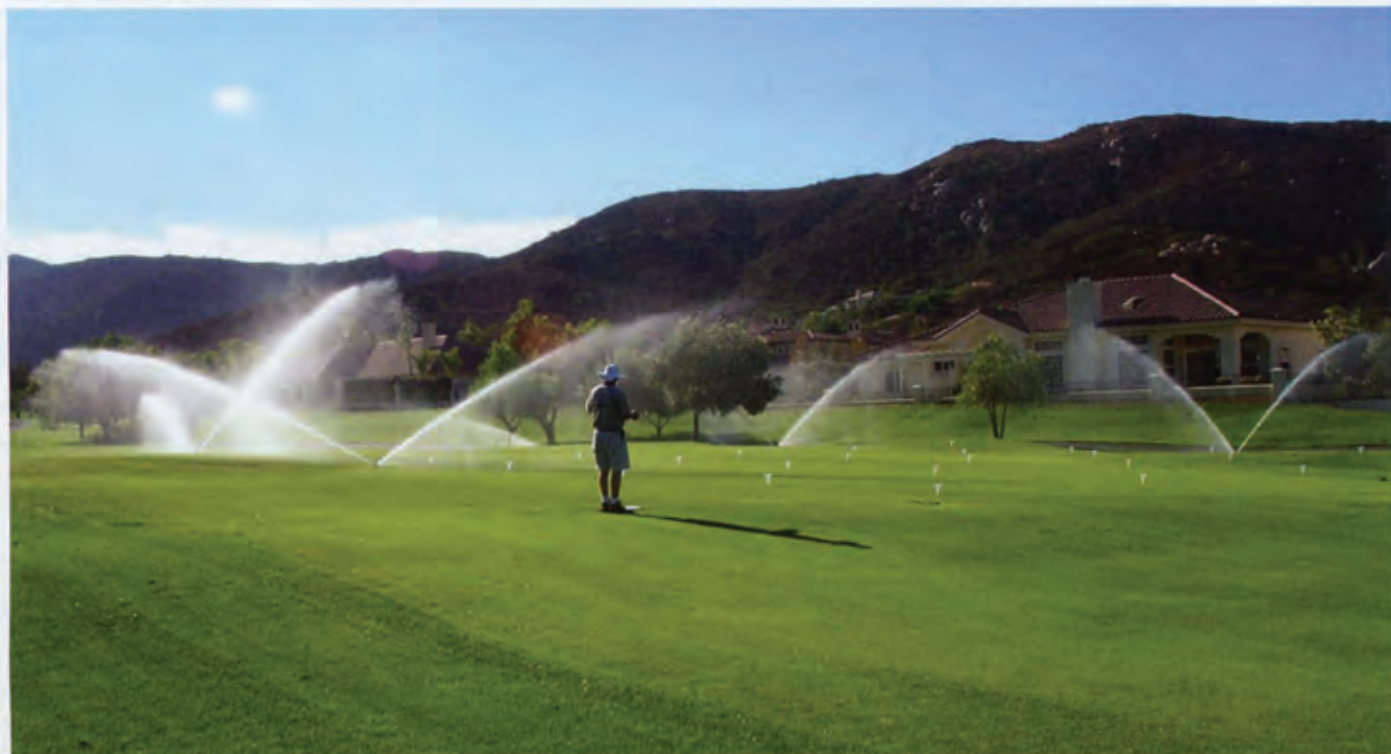
A catch-can test measures irrigation distribution uniformity in the field. Photos courtesy of Underhill

He notes that the best way to fully evaluate an irrigation system's distribution uniformity is either an on-site audit or a laboratory evaluation at the Center for Irrigation Technology. Using catch-can tests, overall distribution uniformity can be measured in the field, while in the lab accurate data can be collected and transcribed into a "profile" that can be used with software that projects performance when overlapped. The profile represents the shape of applied water along the length of a single sprinkler's throw. It is visually displayed as a sloping wedge.

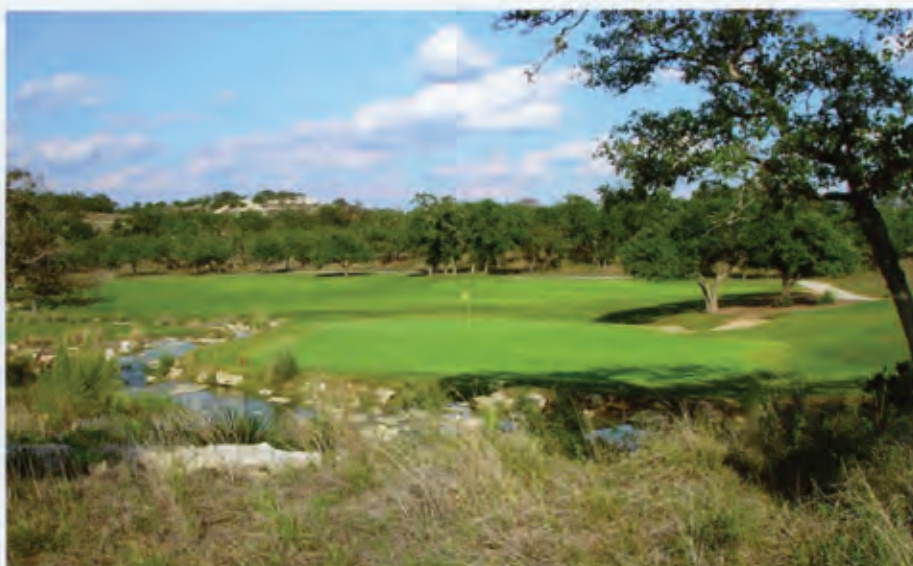
Updating the irrigation system nozzles allowed The Clubs of Cordillera Ranch in Boerne, Texas, to improve distribution uniformity and coverage. Mark Semm is the GCSAA Class A director of agronomy.

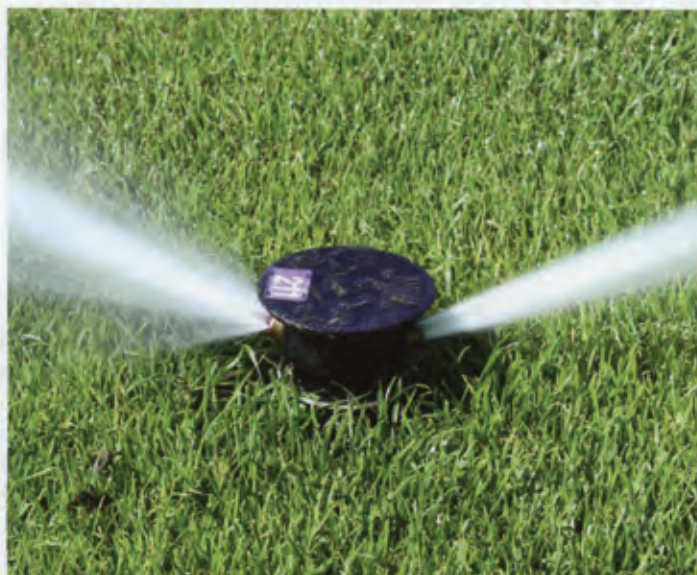
At Cordillera Ranch, retrofitting full-circle heads on the fairways with efficient solid metal nozzles cost around \$6,000.

"The ... retrofit cost approximately \$6,000. Our other option was to replace all the full-circle heads at a cost well over \$30,000. Dollar for dollar, the solid metal nozzles were one of the best investments we ever made. (They) paid for themselves in water, energy and labor savings."
